PROPERTY INSPECTION REPORT

Concerning: 53006 Little River Ct., Fulshear, TX. 77441
(Address or Other Identification of Inspected Property)

By: Chris Zimmerman TREC#21082 Jul 13, 2021
(Name and License Number of Inspector) (Date)

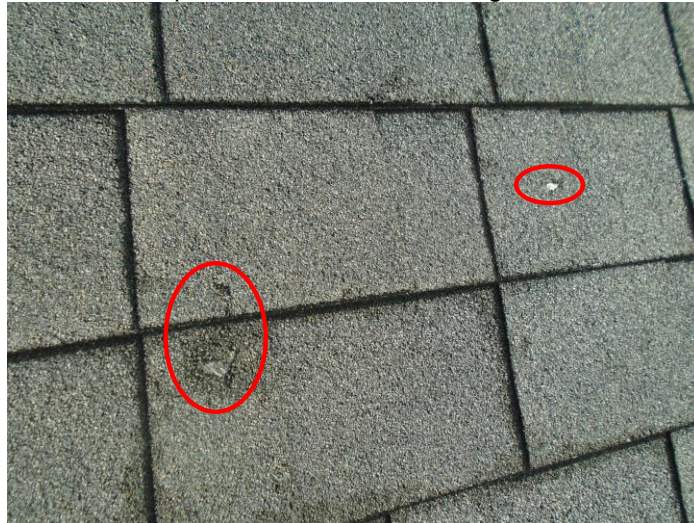
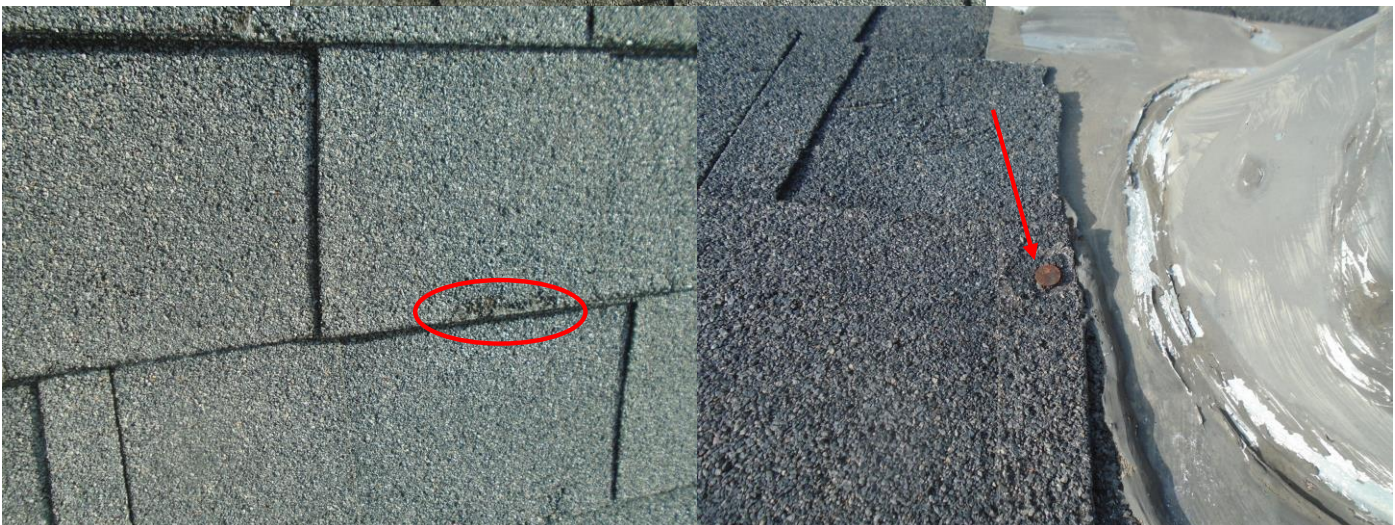
☐ Ridge shingles cracked / missing / loose☒ [Shingles damaged \(Some\)](#)☐ Valley in need of repair☐ Starter strip missing / improperly installed☐ Fasteners improperly installed☐ Fasteners not viewed☒ [Nails or staples exposed \(By roof vent near peak\)](#)☒ [Caulking needed](#)☐ Small holes or openings

Additional Notes: (This inspector is not a roofing expert. Client should have a roofing company inspect the roof for further evaluation if the Client so chooses)

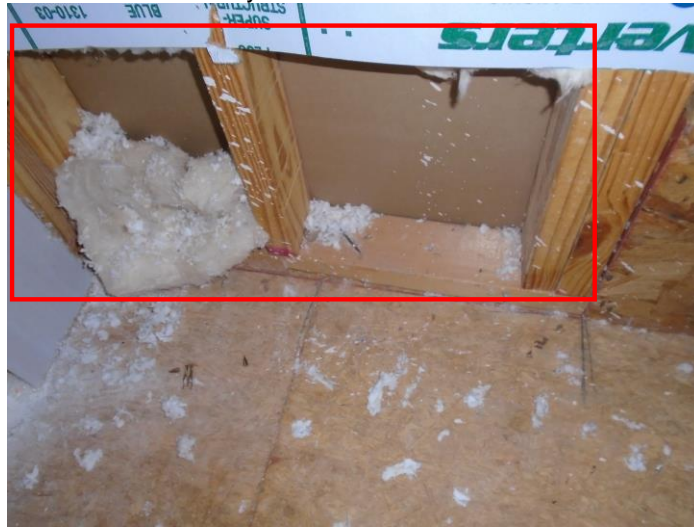
Comments: There is some insulation missing as you go through the attic access at the end of the hall upstairs in the closet to your left.

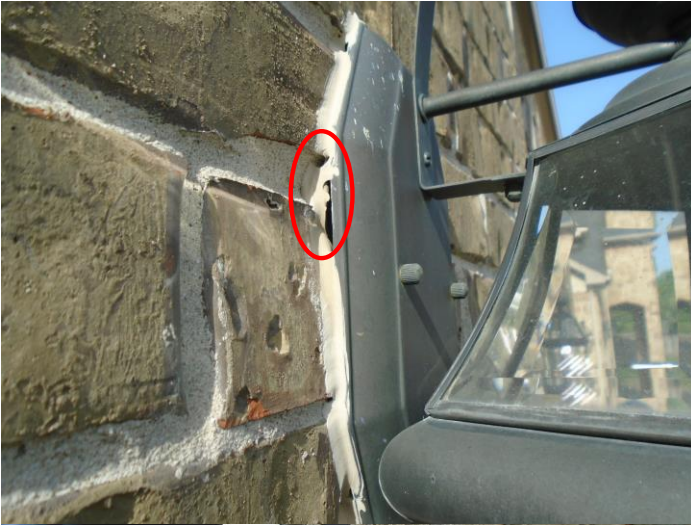
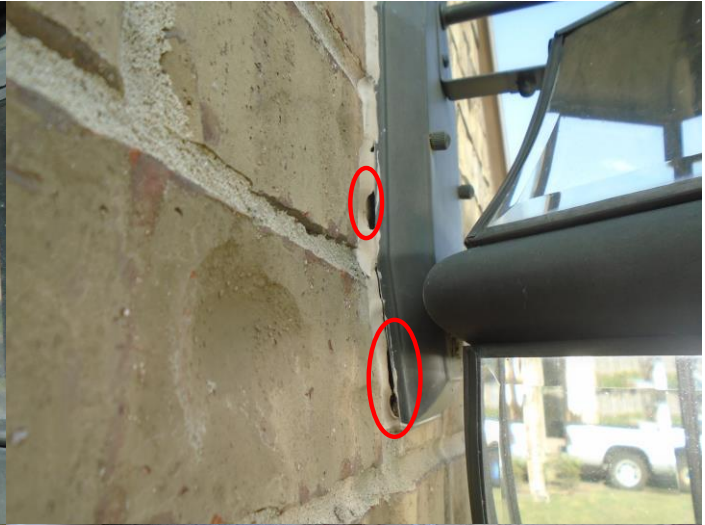
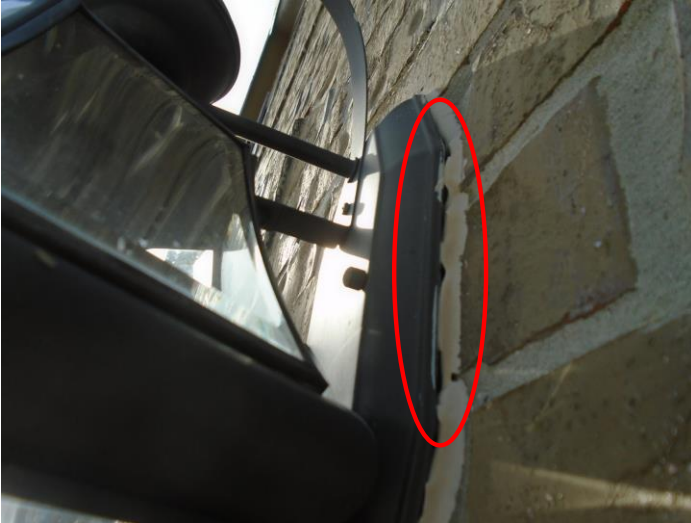
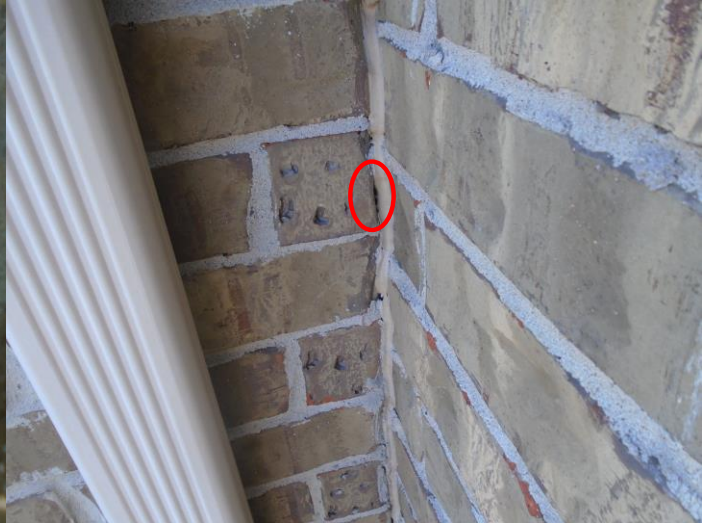
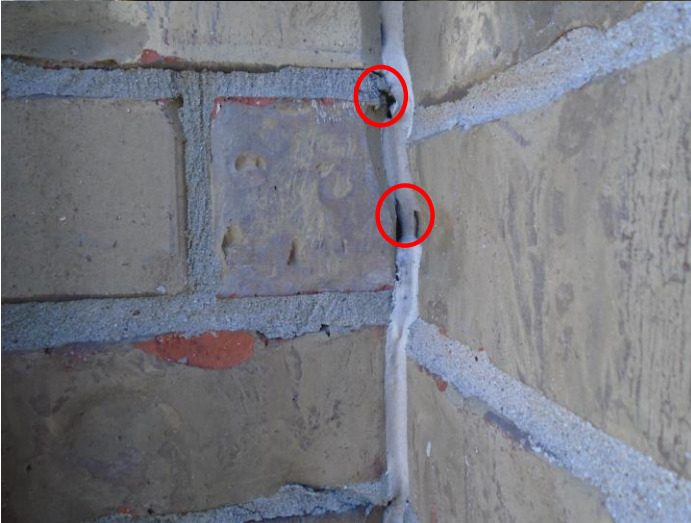
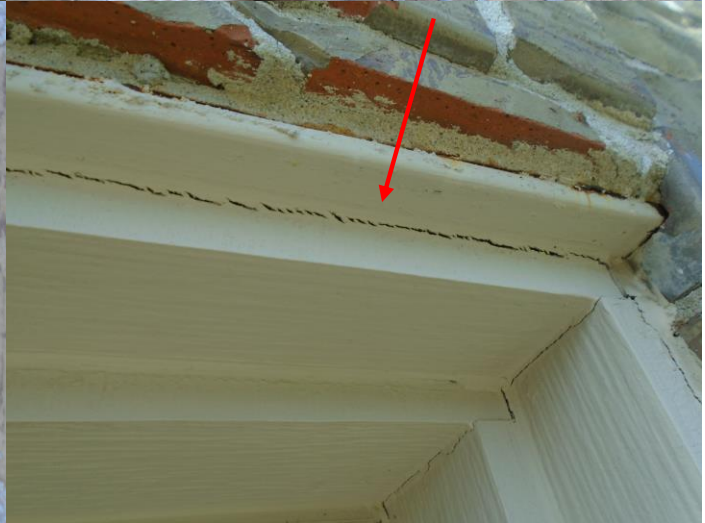
Additional Notes: There is some caulk missing around all three lights mounted on the front of the house. There is some caulk missing from the corners to the left, and right of the front porch. There is some caulk missing around some of the trim to the garage door. There is a small crack in the mortar to the right of the garage door, under the address number. There is some caulk missing around the master bathroom window. There is some caulk missing around some of the windows on the back of the house.

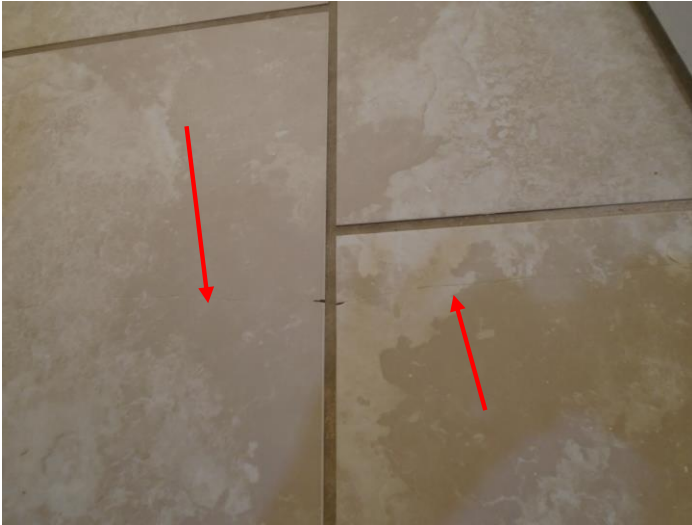
Floors: There is a small crack in some tile on the floor by a door in the Jack, & Jill bathroom.

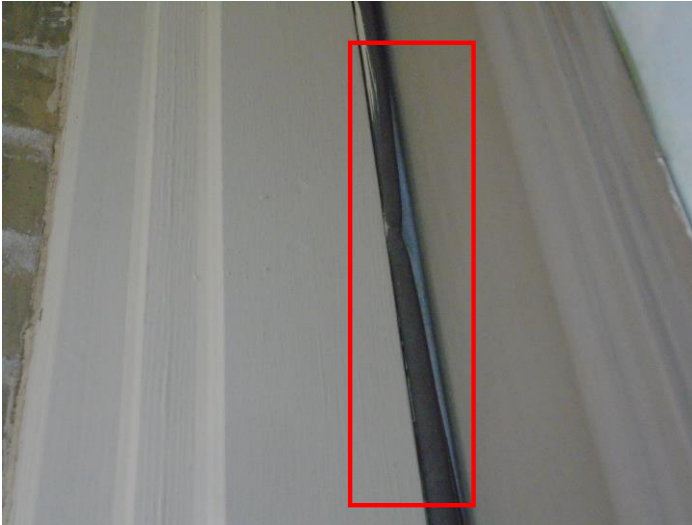
☒ ☐ ☐ ☒
H. Windows*Comments:*Evidence of water penetration: No ☐ Window inoperative ☐ Cracked window ☐

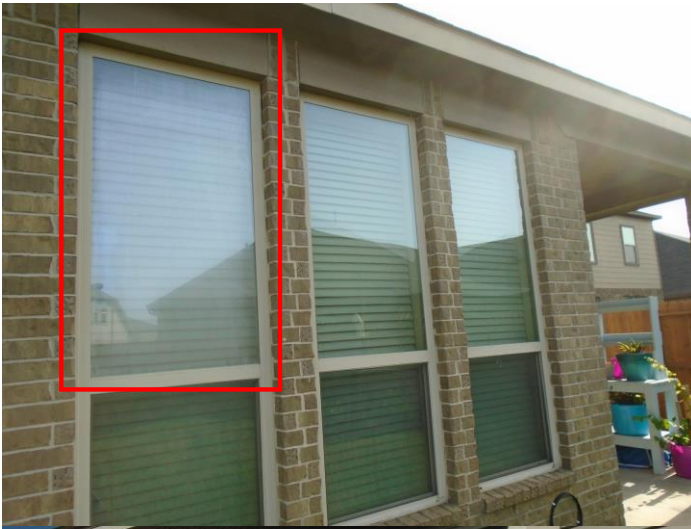
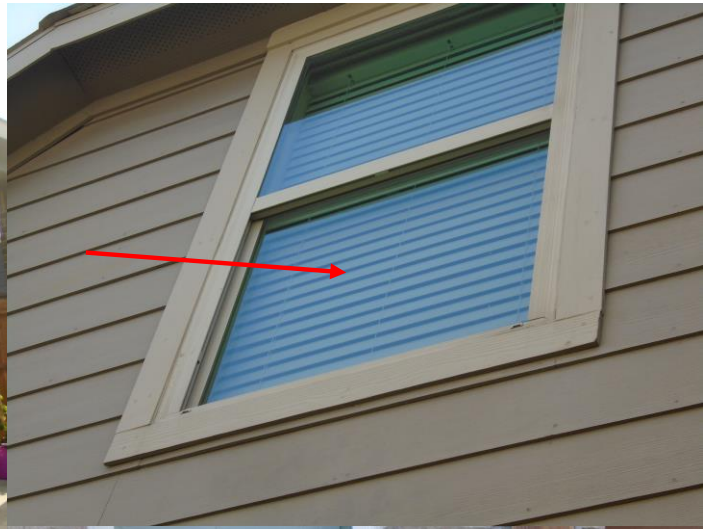
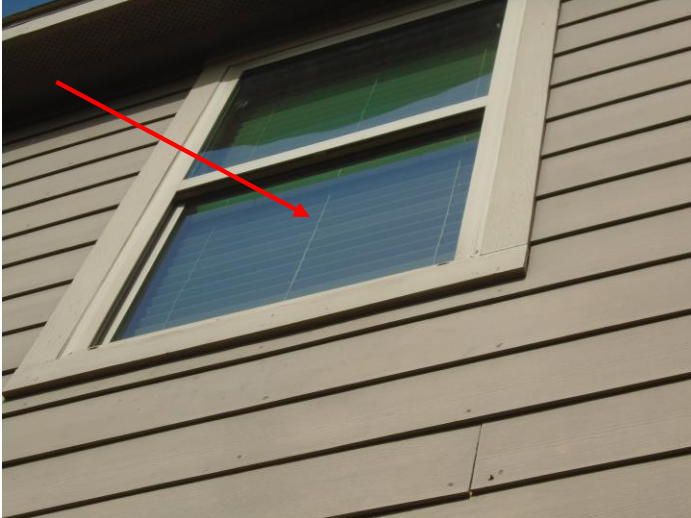
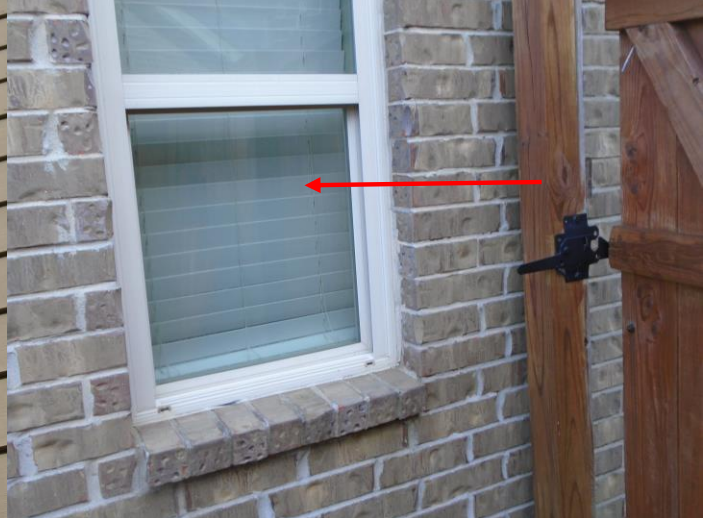
Additional Notes: The window in the living room closest to the fire place has a broken seal which has allowed some of the argon gas to escape leaving the window looking frosted. This window is less energy efficient and should be replaced immediately.

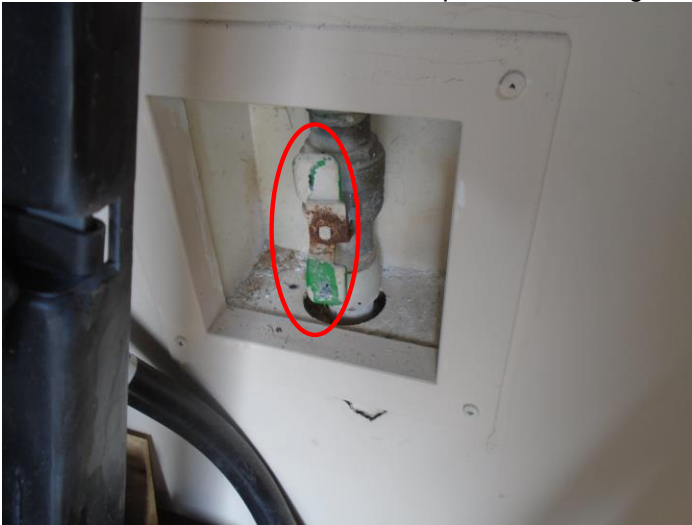
Location of water meter: *Front Yard (Right Side)*Location of main water supply valve: *Garage*Static water pressure reading: *64 P.S.I.*

Note: Water pressure reported was a cursory test, the pressure can vary throughout the day.

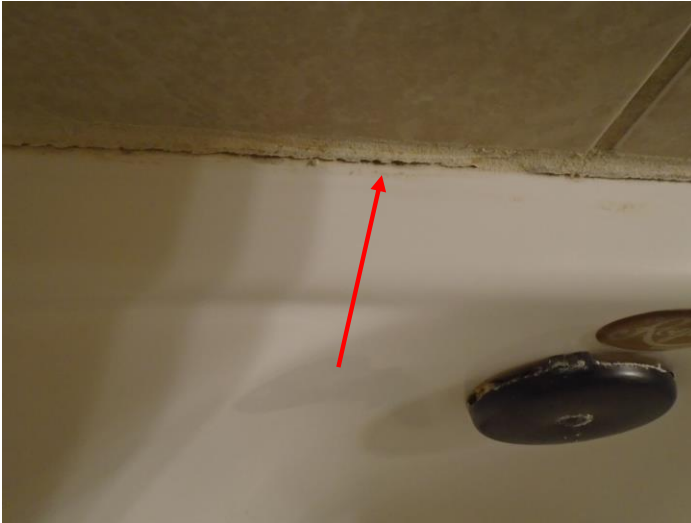
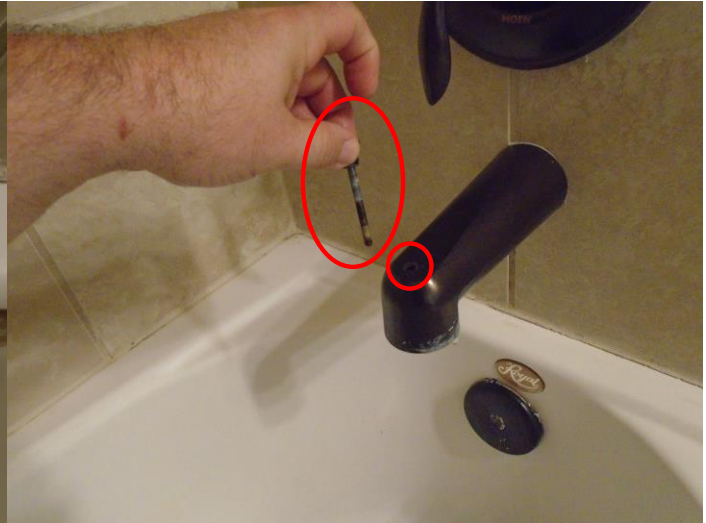
☐ Faucet leak ☐ Faucet/knob missing
☐ Stopper missing/non-functioning
☒ *Diverter non-functioning*
☐ Water damage

☐ Faucet leak ☐ Faucet/knob missing
☐ Head leak ☐ Pan leak
☐ Water damage ☒ *Grout/caulk missing*

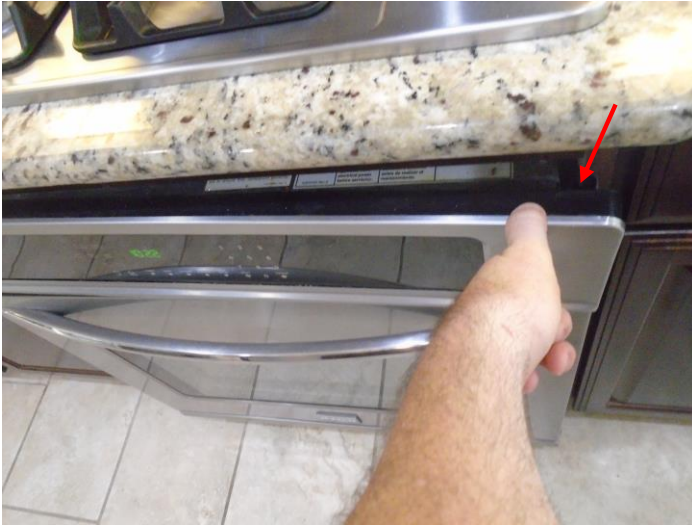
☒ ☐ ☐ ☐
E. Microwave Ovens*Comments:*☐ Light inoperative☐ Door seal damage☐ Microwave inoperative☐ Does not heat properly☐ Door handle missing/damaged
